SIXTH EDITION

2020 PV Module Reliability Scorecard

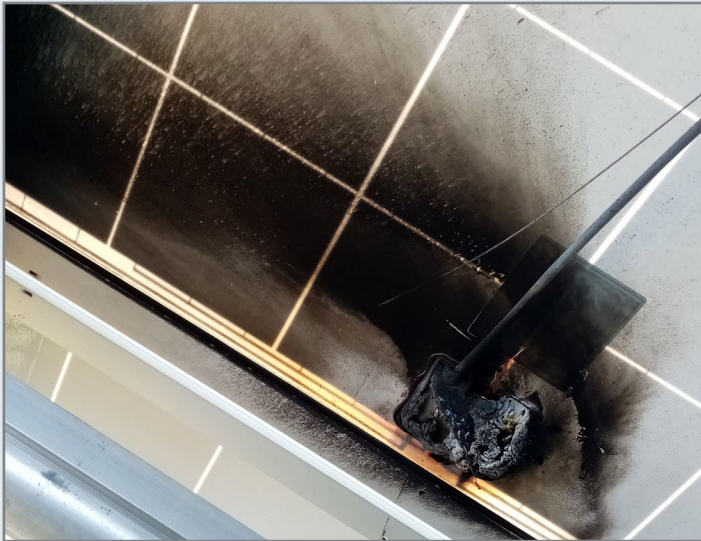
The image above shows a PV module at the project site with a junction box that melted due to electrical arcing.

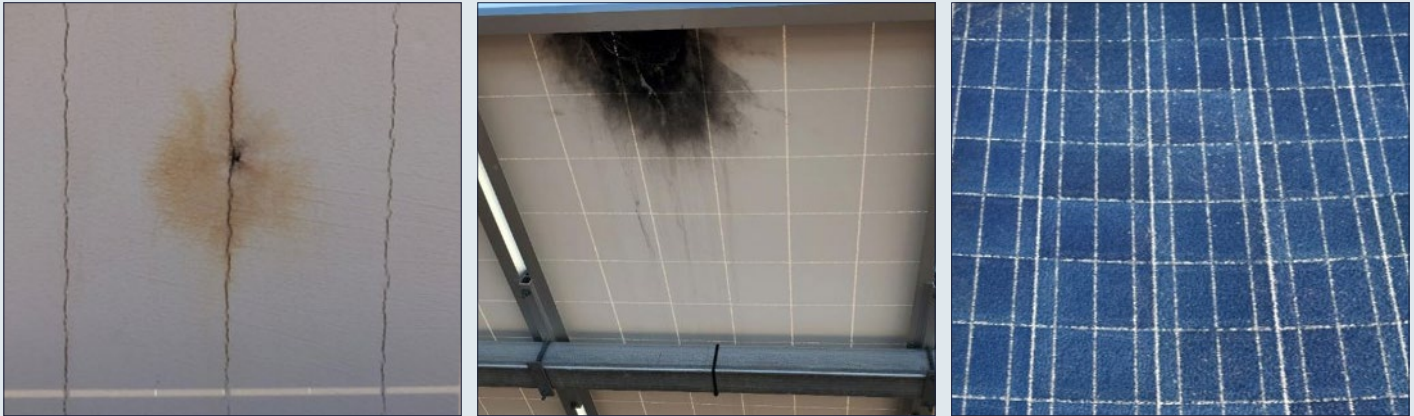
The pictures above are from a 17 MW project in the Southwest U.S. One hundred percent of the backsheets in this project are cracked. The severe scorching in the backsheet above was caused by electrical arcing at the backsheet cracks that intercept the frame. The thermal event shattered the front-side glass.
